# Rock deterioration in the masonry walls of the Cathedral Basilica of Aguascalientes, Mexico

Padilla-Ceniceros, R., Pacheco-Martínez, J., López-Doncel, R.A., Orenday-Tapia, E.E., 2017, Rock deterioration in the masonry walls of the cathedral basilica of Aguascalientes, Mexico: Revista Mexicana de Ciencias Geológicas, v. 34, núm. 2, p. 138-149.

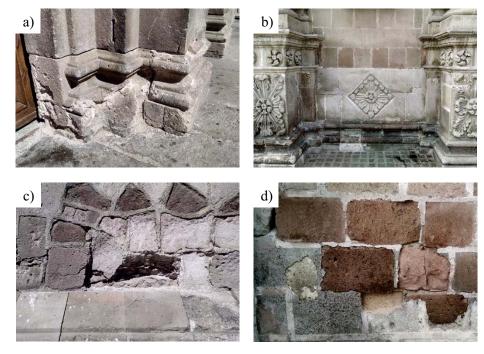
Unfortunately, the low volumetric weight of tuffs is related to high porosity. Hence, tuffs commonly present low mechanical properties (*i.e.* low tensional strenght from 1 to 4 Mpa and compressional strenght from 10 to 45 Mpa, according to Siegesmund and Snethlage (2014), Kılıç and Teymen (2008); Rahn (1996)), and hydraulic properties that favor moisture by capillarity of soil and atmospheric water. Specifically Barranca, Valladolid and San Miguel el Alto tuff report compressional strenght average values up to 28.5 Mpa (Wedeking *et al.*, 2013; Sánchez-Gonzalez and Maldonado-Lee, 2008). Historical buildings in Aguascalientes were built between the centuries 16 to 20. They were built of masonry composed by volcanic rocks mainly tuff. As a consequence, several buildings present damages and deterioration of the masonry stones, mainly at the base of walls due moisture, which favor salt crystallization. In turn, salt crystallization has favored developing of stone decay in the cathedral stones such as flaking and scaling, black crusts (Figure 1).

Figure 1. Deterioration of the Aguascalientes City Cathedral due to weathering and moisture. a) Black crusts, soiling, scratch, moist areas and raising damp on a wall at a right side of the main access to the temple, b) black crusts and contamination by human waste, soiling y rising damp in the bottom of the wall at the right side of the access door. c) and d) rising damp and flaking on rocks on the northern wall.

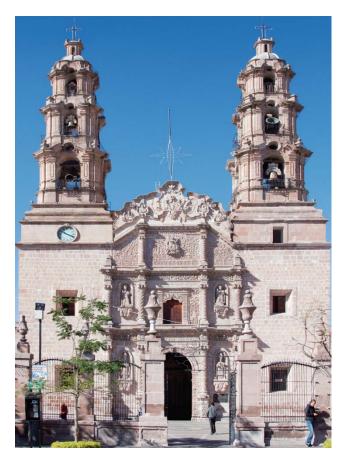
Figure 2. Image taken from the main facade of the Cathedral Basilica of Aguascalientes City.

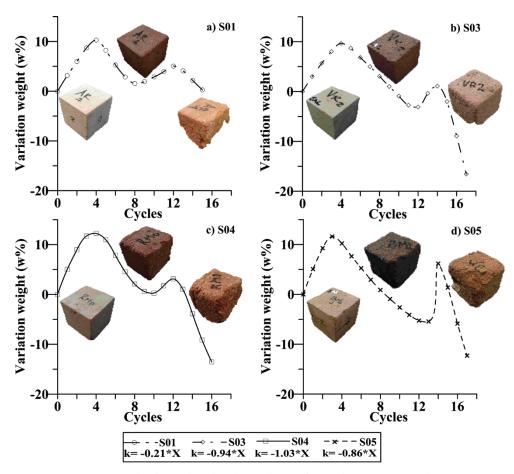
Figure. 11. Graphs of Stone decay by salt crystallization for samples S01, S03, S04 and S05.

All of tested stones in this work disintegrate approximately at the 16th cycle of the tests (Figure 11). This means that in spite of their differences shown of the other determined parameters (absorption rate, water uptake capacity, and porosity), the tested stones have similar resistance to be deteriorated by salt crystallization.

Salt crystallization test shown that all stones have the same resistance to be deteriorated by this effect (approx. 15–17 cycles) and this is totally dependent on the high porosity values of all studied samples (all of them > 25% porosity). Nevertheless, stones present different deterioration rates, being the stones S03 and S04 the ones that are more quickly deteriorated, and the stone S01 the one that has the lowest rate of deterioration. Therefore, the original stone S01 is the most appropriated one to be used in future restorations.
