# Rock deterioration in the masonry walls of the Cathedral Basilica of Aguascalientes, Mexico

Padilla-Ceniceros, R., Pacheco-Martínez, J., López-Doncel, R.A., Orenday-Tapia, E.E., 2017, Rock deterioration in the masonry walls of the cathedral basilica of Aguascalientes, Mexico: Revista Mexicana de Ciencias Geológicas, v. 34, núm. 2, p. 138-149.

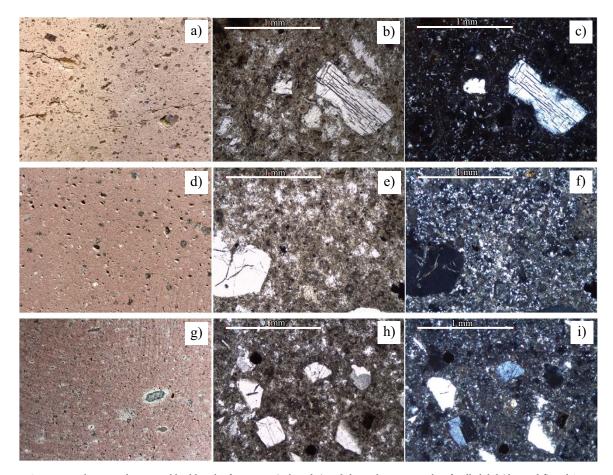
Figure. 3. Comparison between the original build rock of Barranca (a, b and c) and the replacement rocks of Valladolid (d, e and f) and San Miguel El Alto (g, h and i). The differences in texture and mineral composition are clear to recognize (explanation in text). a, d and g: Macroscopically aspect of the samples in hand specimen. Length of the samples 5 mm. b, e and h: Microphotographs of the studied tuff rocks in thin section with parallel nicols. Length of the photography 2 mm. c, f and i: Microphotographs of the studied tuff rocks in thin section with crossed nicols. Length of the photography 2 mm.

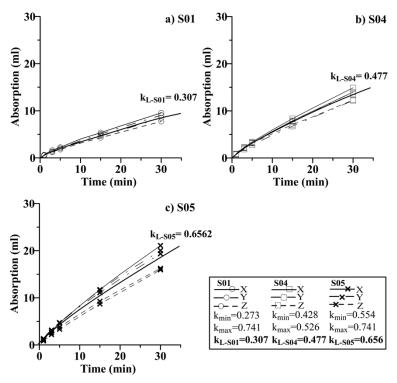
Figure 8 shows the graphs of the 3 stones (S01, S04 and S05) tested with the Karsten tube to determine the absorption rate or water penetration rate. The graphs shows that the stone having the highest absorption rate is the one S05 and that stones show hydraulic anisotropy. This is showed by the fact that in all graphs, X side is the one with the highest rate of absorption, while the lowest rates of absorption correspond to the Z side.

Figure. 8. Water absorption capacity in laboratory test for samples S01, S04 and S05.  $k_{min}$ ,  $k_{max}$  and  $k_L$  (ml/min) are the minimum, maximum and average absorption coefficients respectively, determined in lab.

Even though the absorption lab test shows that the stones have hydraulic anisotropy, if it is considered that variations of absorption for the different sides of a stone sample are in the same magnitude order (Figure 8), and then anisotropy is not significant for all tested stones.

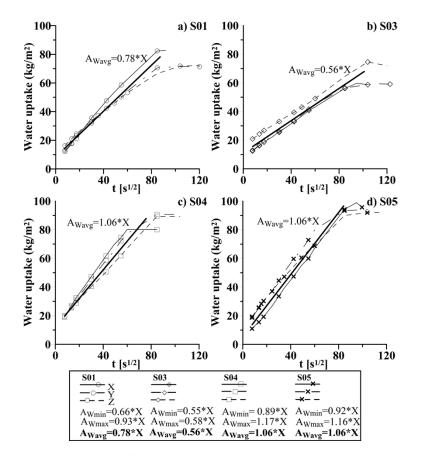
Figure 9 shows the graphs of the tested samples with the water uptake test (S01, S03, S04 and S05) according to DIN ISO 15148 (DIN, 2002). The Graphs shows that stone S05 is the one that has the highest capacity to uptake water by capillary, which is consistent with results of absorption tests both *in situ* and in lab (Figures 6 and 8).

Figure. 9. Water uptake by capillary obtained in the four samples: (a) S01, (b) S03, (c) S04 and (d) S05.  $A_{Wmin}$ ,  $A_{Wmax}$  and  $A_{Way}$  are the minimum, maximum and average water uptake coefficientes respectively, determined in lab. The thick line is the average trend line in each sample.

Even though the results of the hydrostatic weight test indicate that stone S04 (from Valladolid) is the one with the highest effective porosity, determinations in lab show this one presents values of absorption rate and water uptake coefficient very close to those of stone S05 (Figure 8 and 9). Hence, these results suggest that stone S04 is also a stone prone to uptake water by capillary and consequently also more prone to be deteriorated by salt crystallization as the stone S05. In addition, results of hydrostatic weight show that stone S03 has a less porosity (Table 3), which is consistent with the results of the water uptake and absorption rate tests.

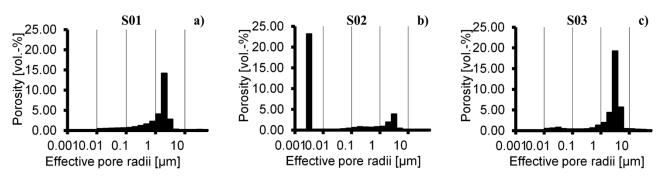
Table 4 shows the results of the hydrostatic weight test performed in stones S02, S03, S04 and S05, and Figure 10 shows the pore radii distribution of the original and the remplaced stones S01, S02 and S03. The pore radii distribution shows clearly, that the original building rock content almost exclusively macropores, while the replacement rock (S02) has mainly micropores. The last used restorations rock (S03) has a very similar distribution as the original rock.

Porosity can be classified according the pore size (Siegesmund and Dürrast, 2014): microporosity (pores smaller than 0.1  $\mu$ m); capillary pore (pore size from 1  $\mu$ m to 1 mm), and macroporosity (pores larger than 1 mm). Results showed that stones S01 and S03 have capillary pore, while stone S02 presented almost only microporosity (Figure 10).

Figure. 10. Pore radii distribution and total porosity for stones. a) S01, b) S02 and c) S03.
