## Experimental study of infiltration through subsidence-reactivated surface discontinuities

Martín Hernández-Marín<sup>1,3</sup>, Norma González-Cervantes<sup>1</sup>, Lilia Guerrero-Martínez<sup>1</sup>,  
Christian Emmanuel Rodríguez-Padilla<sup>2</sup>, and Jesús Pacheco-Martínez<sup>1,3</sup>

<sup>1</sup> Departamento de Ingeniería Civil, Universidad Autónoma de Aguascalientes, Av. Universidad No. 940, Ciudad Universitaria, C.P. 20100, Aguascalientes, Mexico.

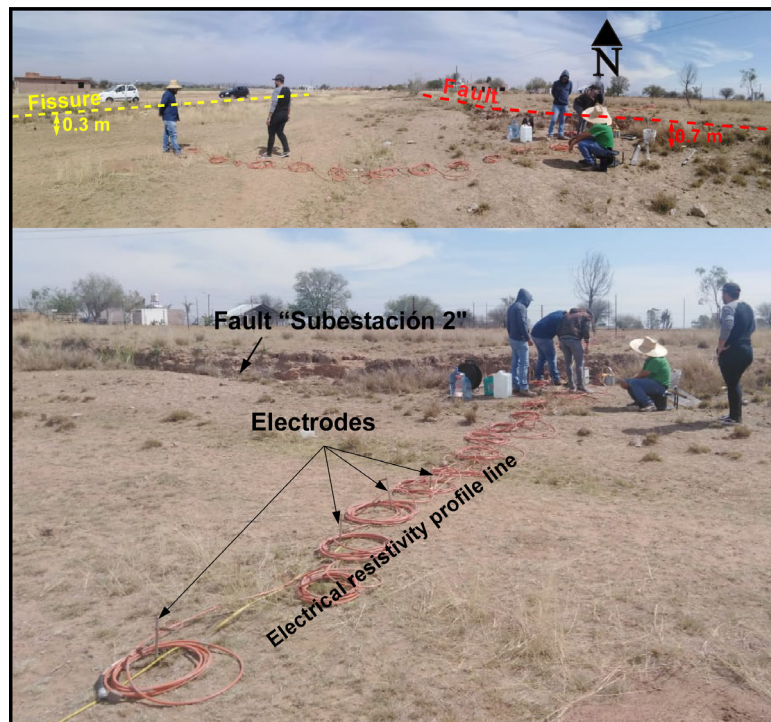
Figure 3. Photograph during fieldwork where both discontinuities are shown. The photographs were taken during the application of the ERT method.

In general, the methodology consisted of applying Electrical Resistance Tomography (ERT) and subsurface permeability techniques in the experiment area (Figures 2 and 3). The first basically involved applying an electrical current to subsoil through surface electrodes and analyzing the soil response. Under this technique, the less moisture and salinity in pore water in the soil the more resistive the soil. While the permeability test consisted of measuring the hydraulic conductivity and infiltration rate parameters of the soil. Both techniques were initially applied in a line on the surface approximately perpendicular to the planes of both discontinuities (line A-A', Figure 2c), obtaining general profiles of ERT (38 m) and permeability (33 m). These general profiles were performed to observe the overall behavior of both discontinuities to the application of the two techniques.

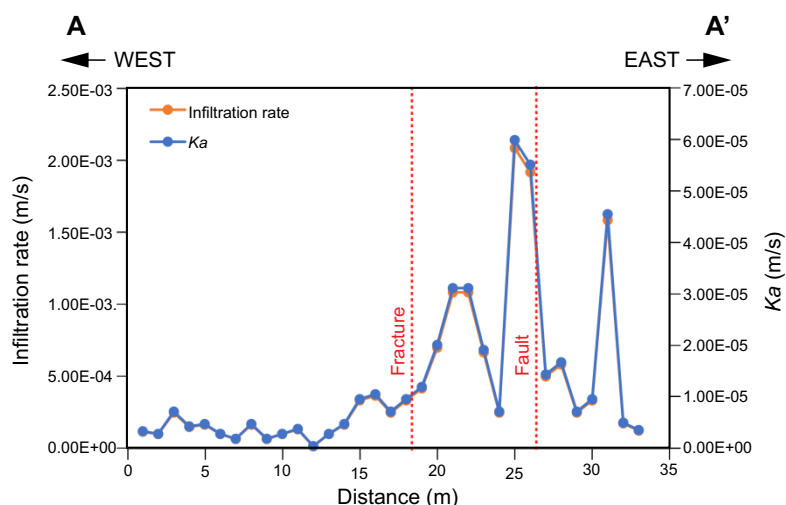
Figure 7. Variation profile of both the infiltration rate and the hydraulic conductivity ( $K_a$ ), obtained from the tests with the Pask-type permeameter. As can be seen, both parameters maintain an approximate linear variation.

Figure 7 shows the profile A-A' (see Figure 2c) with the results of the permeability tests. It should be noted that the two points with the highest values of both parameters are located near the fault and in general, the higher values are mainly presented between the fault and the fracture. As observed, the values of both parameters are lower by several orders of magnitude to the west of the fracture and at the east of the fault, except for a single point with high values at 8.5 meters to the east of the fault. In the area between both discontinuities, several small surface cracks (openings less than 5 mm) were observed, likely influencing the values of the hydraulic parameters. These small cracks are probably related to the mechanical activity of both discontinuities and form a network of subsurface cracks, although further investigation is required to confirm this.
